Historic, archived document

REGION

7

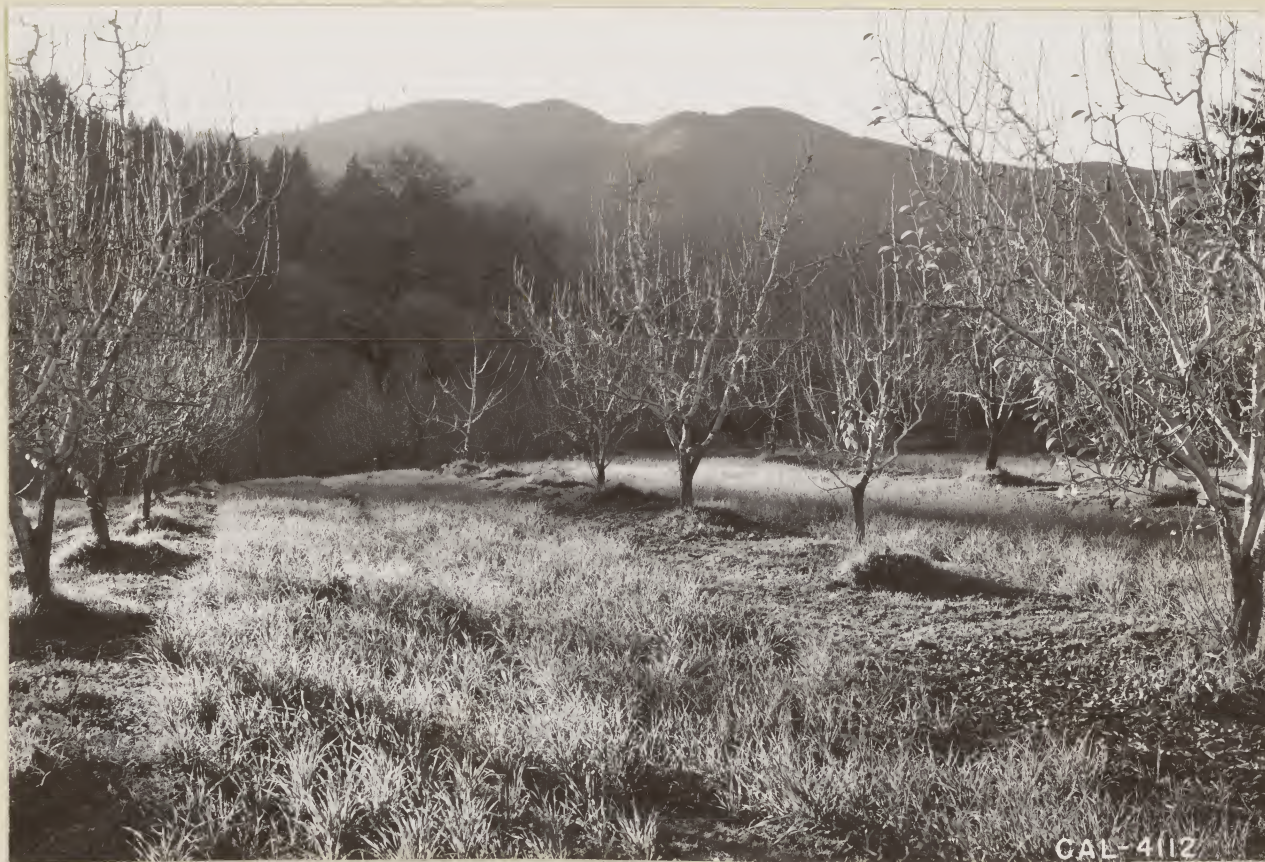
Cal. 3944 -- June 1, 1937 -- Frank Buttram, Los Angeles County,
4 miles South of Puente, California

It has long been the practice to bench terrace the hills of this area
prior to planting citrus orchards. See photo number Cal-3858-59-60 for
a closer view of these terraces and a description of construction.
Purpose of photo: Record.

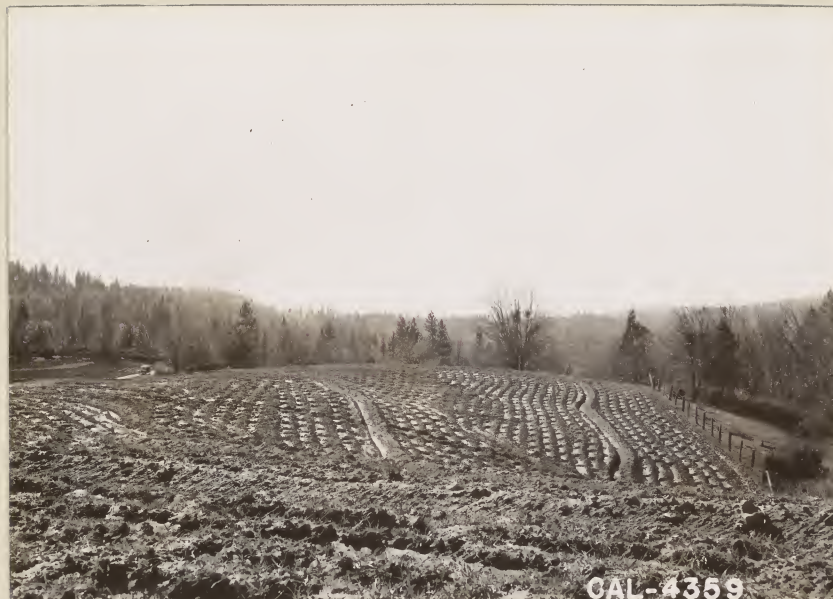
CAL-4359

A control system combining contour basin-listing and permanent grade ditches.

Where the surface was irregular, some of the basins did not hold. Water from these was carried off by the grade ditches.

This area will later be strip cropped between these ditches.

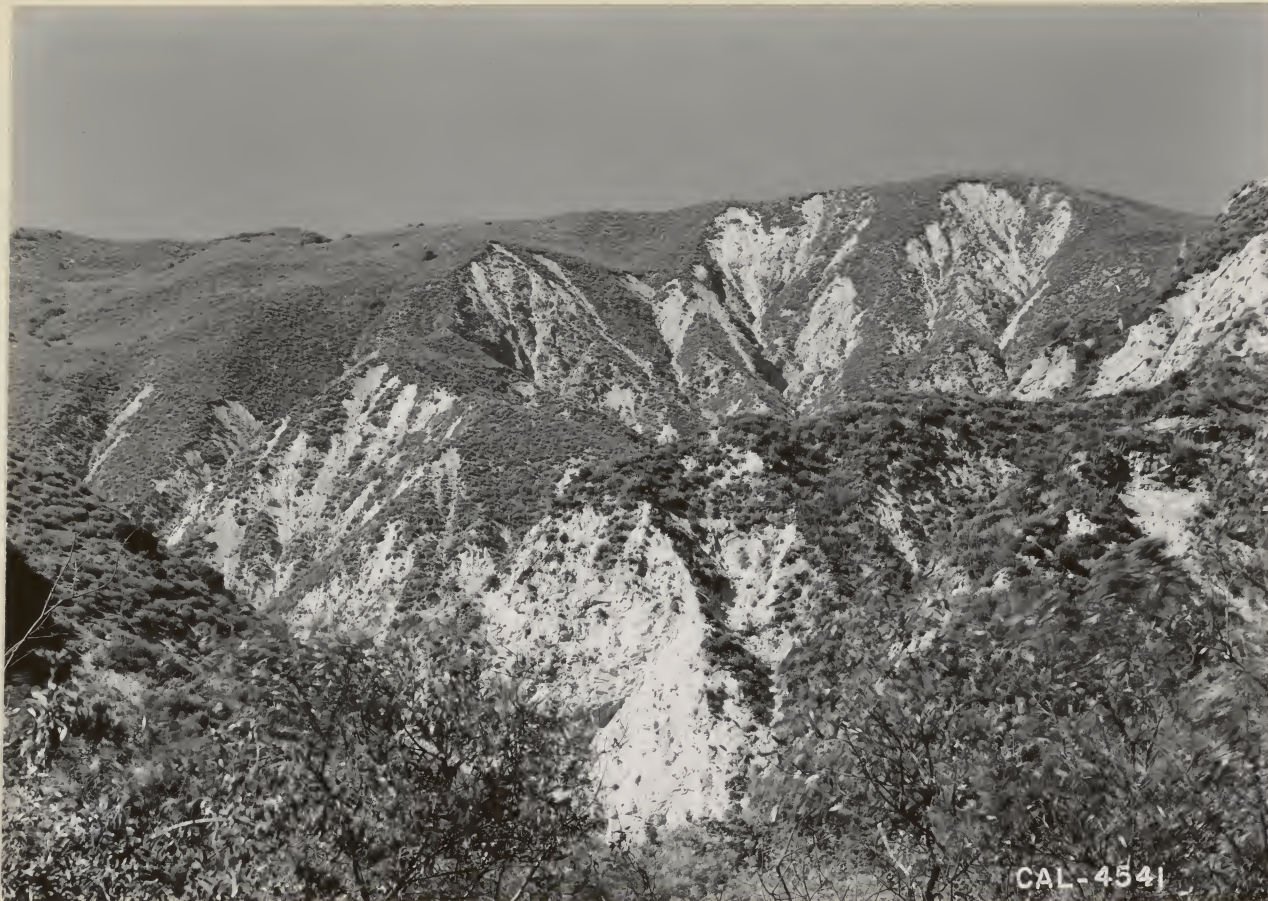
Cal-4541

View of upper portion of Nigger Canyon watershed looking north from a point on the west side of the canyon opposite the upper burned area. It is estimated that the major portion of the debris and silt deposition on the overwashed areas below has resulted from run-off transposition from the slips shown. An estimated 160,000 cubic yards of silt and debris was deposited over an area of approximately 90 acres of valuable agricultural land, about half of which was in full bearing citrus orchards during the 1937-38 storm periods.

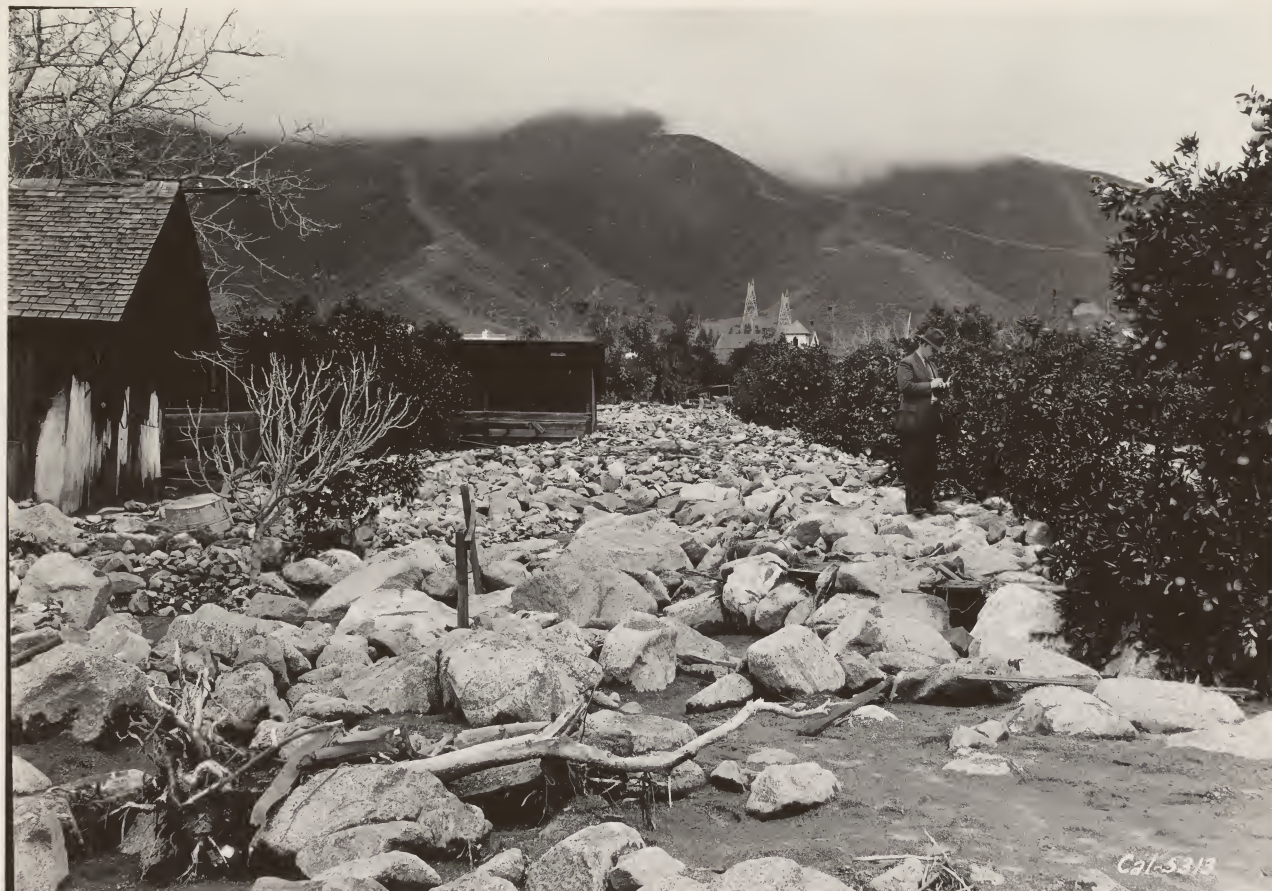
Cal-5313

Heavy rock and debris deposited in citrus orchard near Los Angeles as a result of a storm in precipitation on watershed denuded by fire. Floods of this type frequently occur even though watersheds are quite small, sometimes containing less than 5 square miles when the vegetation is burned from steep slopes in Southern California.

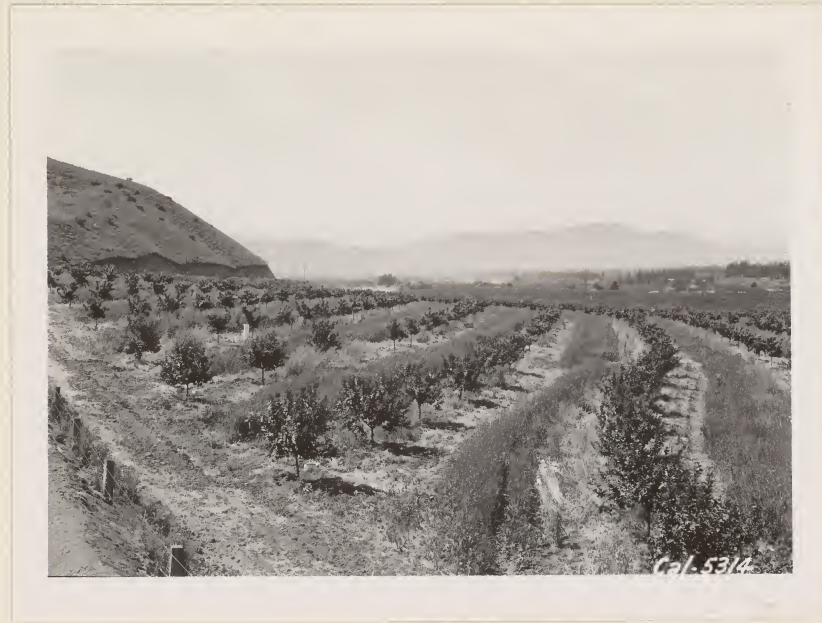
Cal-5314

A modern citrus planting in Southern California with carefully engineered field outlay including irrigation system, roads, and contours. Natural seeding of Lupin used for cover crop had changed this field into a sea of blue at the time the picture was made. Light disking had been performed next to the trees in order to facilitate the plowing of irrigation furrows. The trees are about $2\frac{1}{2}$ years old.

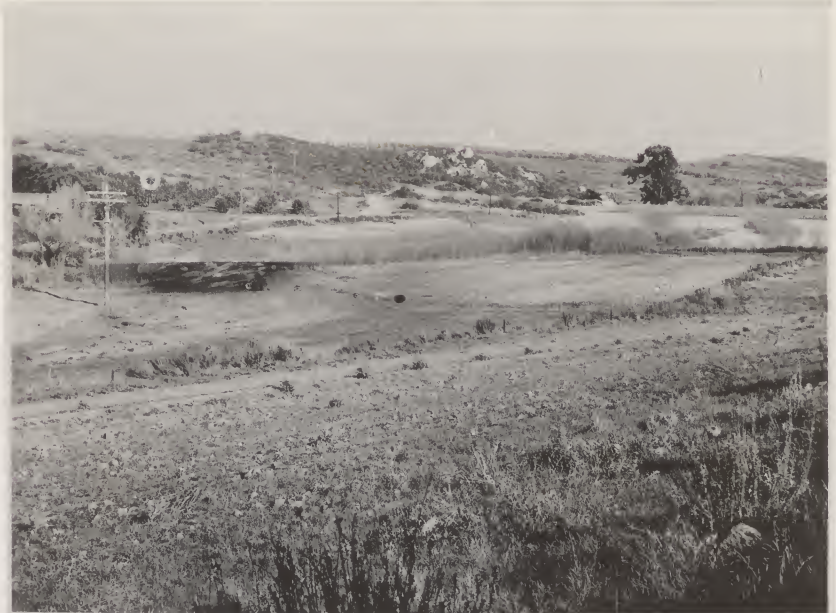
C-6599 *Calif.* Harper Property Photo No. 5
Shows water impounding percolation basin created by construction of earth fill dam and concrete-lined spillway. The water stored in underground supply is pumped from well below for irrigation purposes on this property. It is anticipated also that supply for windmill shown in left of picture will be augmented by rising water table.

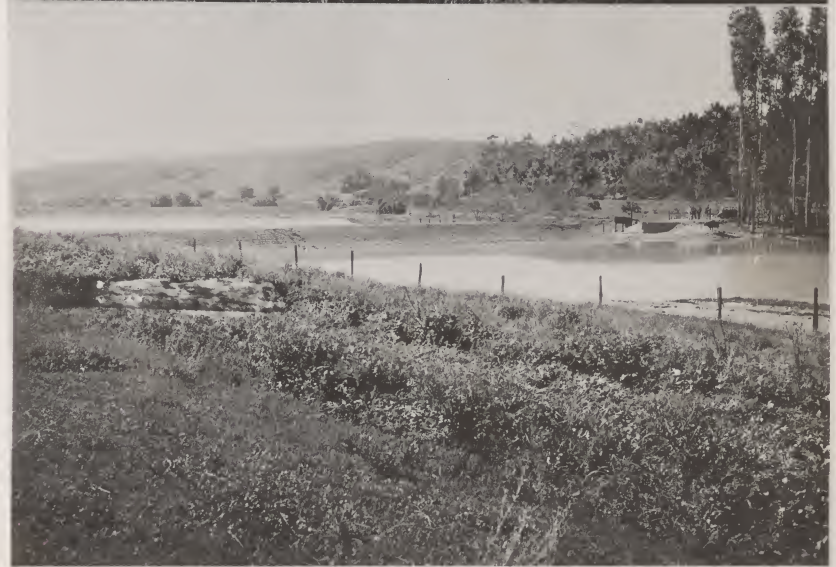
C-6599 *Calif.* Anthony Property Photo No. 4
Shows 2 water impounding percolation basins created by construction of earth fill dams with concrete spillways, across wide swale. Bottoms of these basins are composed of pervious gravelly soil which allows rapid percolation of impounded run-off water into natural underground storage basins. The owner of this property has checked water level in well from which he pumps irrigation water, finds there is rapid increase in height of standing water in well after basins are filled and that pumping lift has been decreased sufficiently to allow him savings in pumping costs that greatly exceed the annual cost of the Water Facilities development. Silt deposition in these basins is removed when necessary. However, the condition of the watershed is such that this is a minor problem. Fallbrook Water Facilities Area.

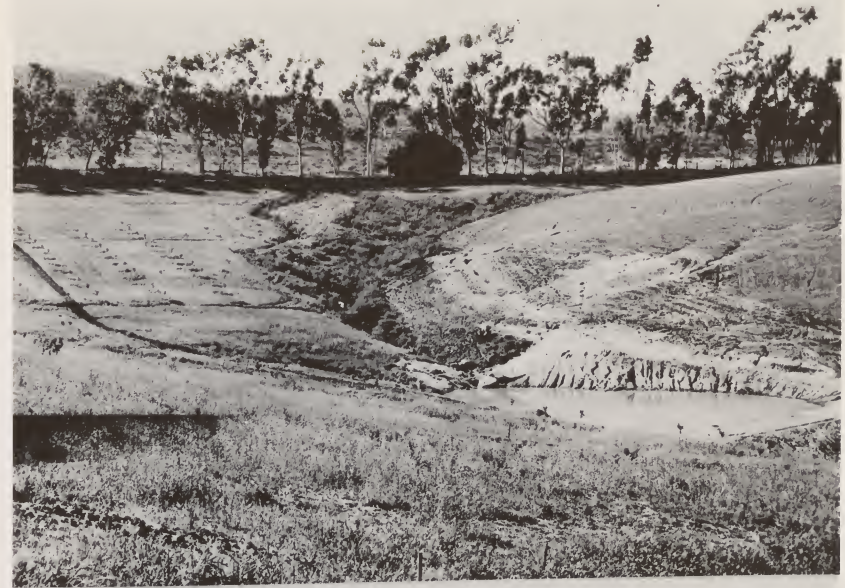
C-6600 Elmer N. Kane Property
Shows water impounding percolation basin
formed by construction of an earth fill dam
with a drop inlet concrete pipe spillway,
and adjoining land which is a portion of
about 6 acres recently planted to citrus and
avocados to be irrigated from the water
developed by this basin and natural under-
ground supply. The irrigation water is pumped
through an underground steel pipe system and
applied by means of a portable irrigation
system. The water facility also includes the
digging of a well and installation of a pump
and motor. Santa Ana.

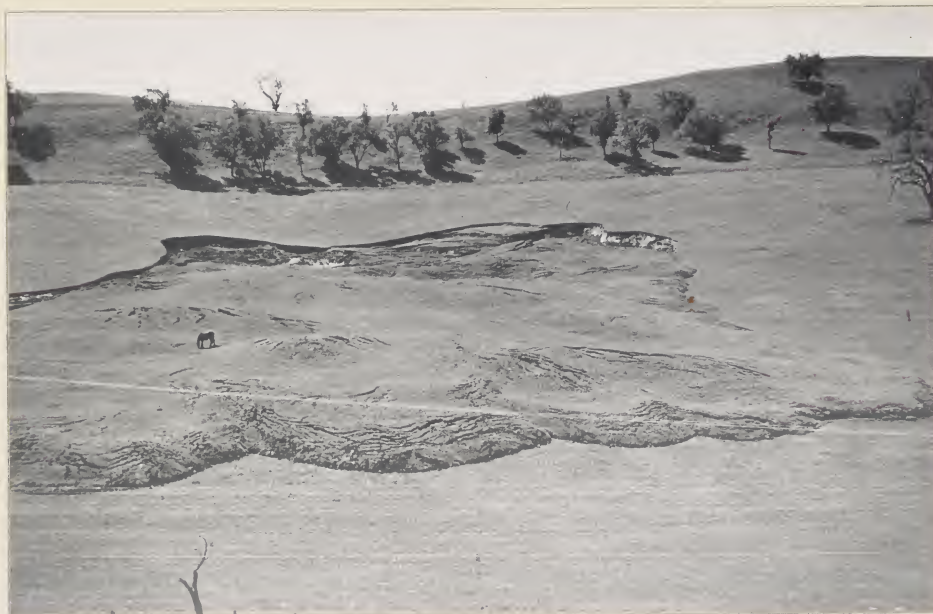
C-9936 - 1941

Land slip near Vacaville, Calif. Soil--loam to heavy clay loam surface soil from one to three feet deep, overlying compacted heavy clay loam subsoil varying from one-half to two feet in thickness. The substratum consists of loose decomposed shale which apparently tends to settle or shift when saturated, resulting in mass movement of the soil above. Use--Range. Grasses: All annuals--Bur clover, Soft chess, Annual Fescue, Wild Oats. Field is overgrazed at present and has apparently been overgrazed over a period of years.

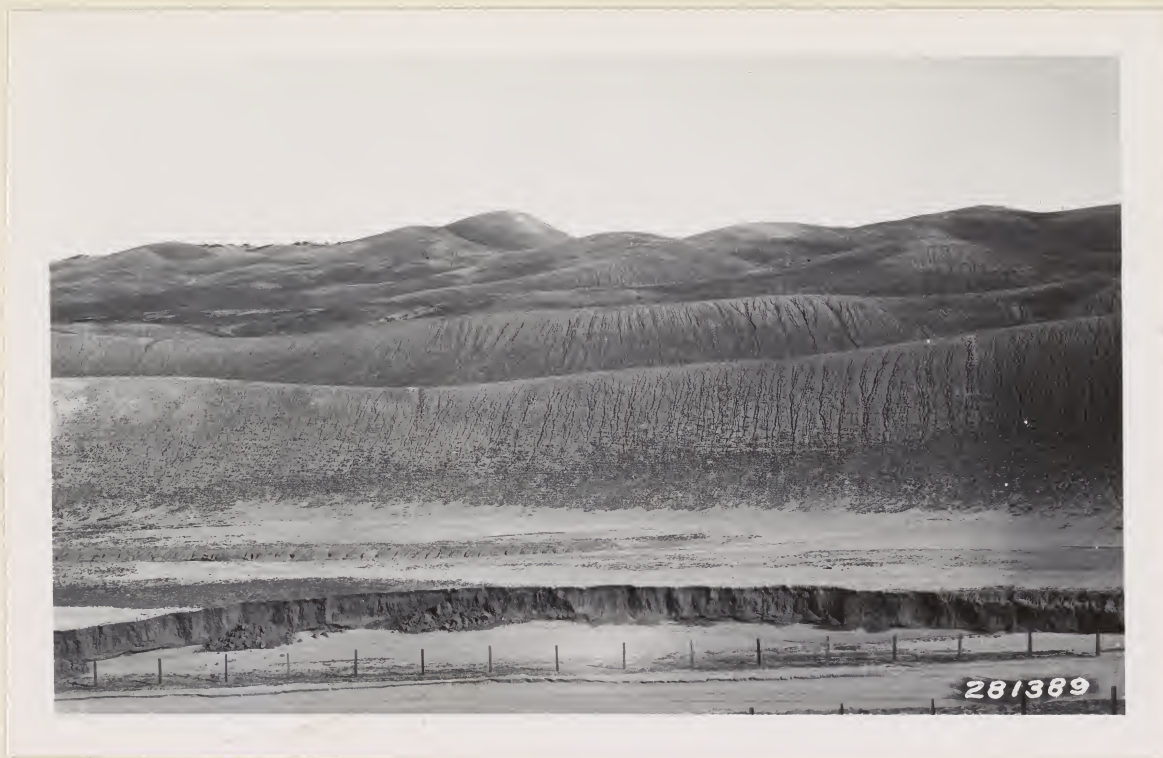
WL-5894. California.
EROSION - Gully.

View of the Tehachapi Pass in southern California, following a single rain.

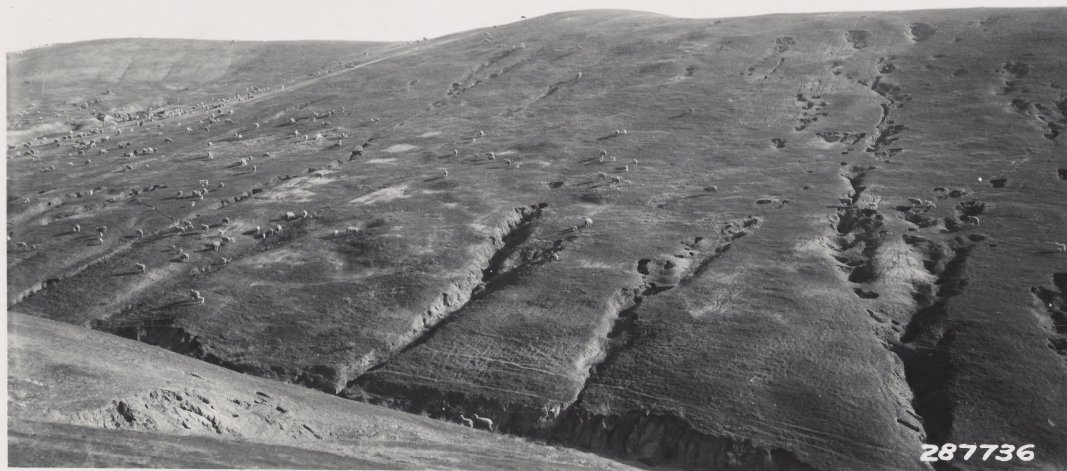
281390

A close-up of one of the hundreds of denuded and gullied slopes on privately-owned sheep range near Monolith, California. Photo by F. G. Renner.

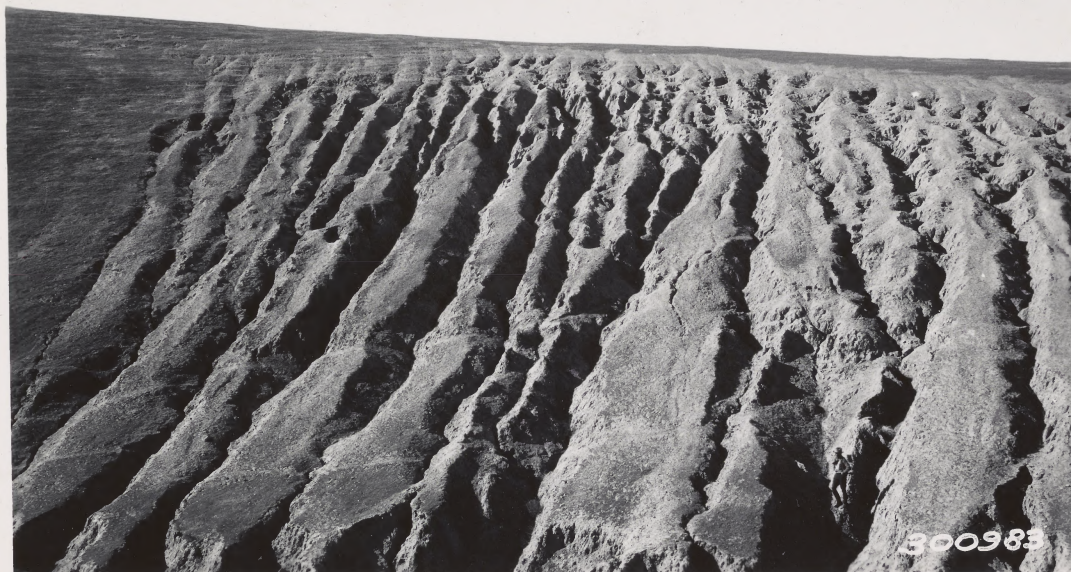
300983

The last stage in range deterioration caused by criminal over-use by livestock. Protective plant cover destroyed, top soil gone. Depth of gullies indicated by figure of man in lower right foreground. Near Tracy, California. Photo by F. G. Renner.
